# Technical Report III

## The Office Building

Brett Miller

11/22/2013

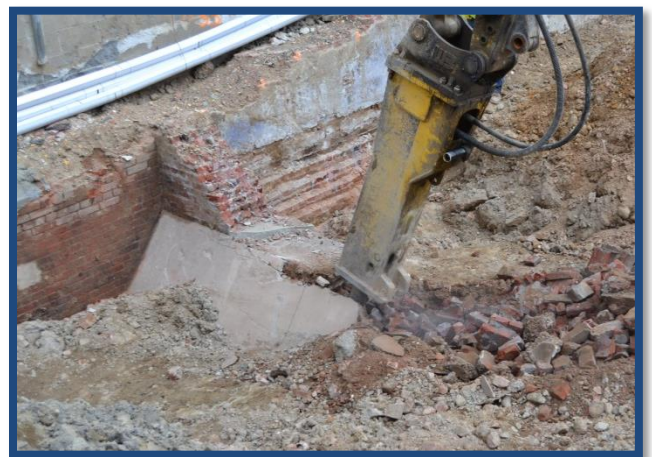
Figure 2. Neighboring Foundation | Courtesy of DAVIS

Another schedule risk the team experienced would be finding the neighboring foundation while excavating. Figure 2 shows the neighboring foundation two feet over the property line as well as a buttress in the foundation that was taken out. This finding caused a design changes to the secant wall and foundation wall. The new design increased the size of the secant wall to support the weight of the neighboring foundation. In order to offset this change, the thickness of the foundation wall had to be reduced, keeping the West wall the same thickness.

With The Office Building having three levels of underground parking, the need arose for supporting the neighboring foundation. The original design for this support was a wall formed by secant piles. This is an intricate process of drilling and pouring female piles and coming back a few days later to drill and pour the male piles; one that requires much back and forth positioning of the drilling rig. This constant repositioning of the drilling rig caused unforeseen schedule delays. The second analysis will compare the duration of this process with one required for a slurry wall.
