Square 320 Project

1199 F Street NW Wash, DC

Michael Webb
Construction Management

Technical Assignment #3

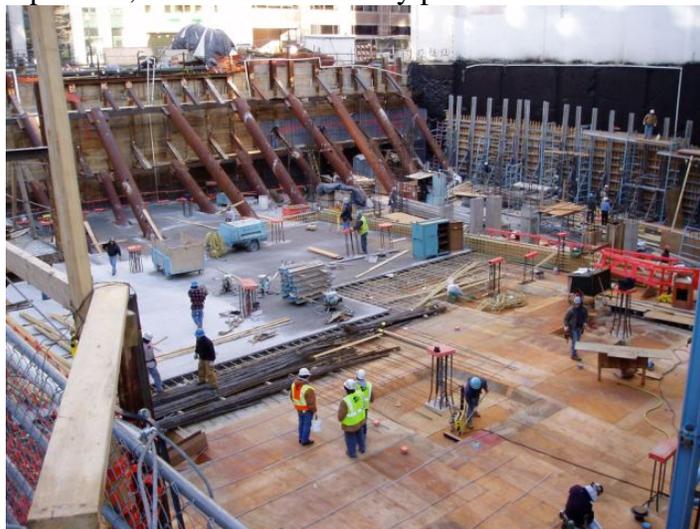
*Figure 1 – Parking Garage During Formwork/Reinforcing
(Notice the Rakers along the west wall in the upper left of the photo)*

The 12-story office tower is built upon a 5 story below grade parking garage. The loads of this entire building are considerable and as such require a highly engineered heavily reinforced structure. In order to adequately transfer the loads on the building to the earth properly a lot of effort and planning went into the buildings construction. The site conditions required an aggressive dewatering plan to drop the water table below the excavation plane. In addition, the construction site falls immediately adjacent to the Washington METRO property line and required excavation right next to the tunnel. Washington METRO was very stringent on the excavation of the soils adjacent to the tunnels and monitored them daily to very strict tolerances. For that reason the excavation of the earth on the west side of the site had to be supported by a significant system of rakers. These huge rakers had to support the walls throughout the excavation phase and well into the superstructure phase until the support had risen to the ground floor. Penetrating each floor of the parking garage were between ten and fifteen rakers that need to be framed around and protected during the concrete pours. The concrete company not only had to plan out before each pour exactly where these holes were located but also planned exactly how they would access each of the necessary areas in the pour to ensure even distribution. This turned what might've been a straightforward concrete pour into a well engineered plan every day the trucks arrived. Additionally, after the structure reached the ground floor the rakers needed to be removed by crane with limited access, the holes had to be patched, and then a secondary pour had to fill in each void.

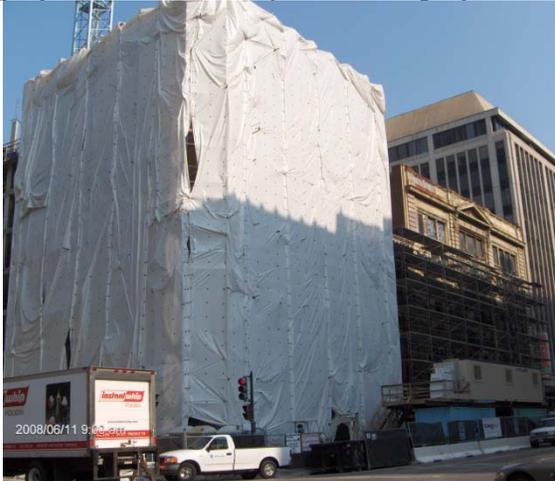
Fig. 2 – B&W Building Façade Restoration

Means of Access – There is one place in the historic renovation portion of the project that has seen a lot of benefit result from the investment of time and money. In the renovation of the historic buildings, work was logically sequenced to occur from the inside out progressing from the demolition and restructuring internally to reappointing the brick faced externally. However, there was a considerable issue with the means of access for the trades to get to the façade of the building especially since their work was to occur after the tower was to be finished and the pedestrian spaces were to be landscaped. In order to make room for the landscapers the only available method for working on the faced would be by calling upon a series of aerial lifts to reach the work. Considering the size of the work to be done and the crew that would be performing it, renting enough lifts would've been a very expensive strategy. Instead, DAVIS organized the work so that the façade could be reappointed while the external scaffolding was still in place while no other trades were working in that area. This alternative strategy likely did not incur any additional cost on the project but it prevented the unnecessary cost of rentals later in the project and effectively saved the project a significant amount of time and money.

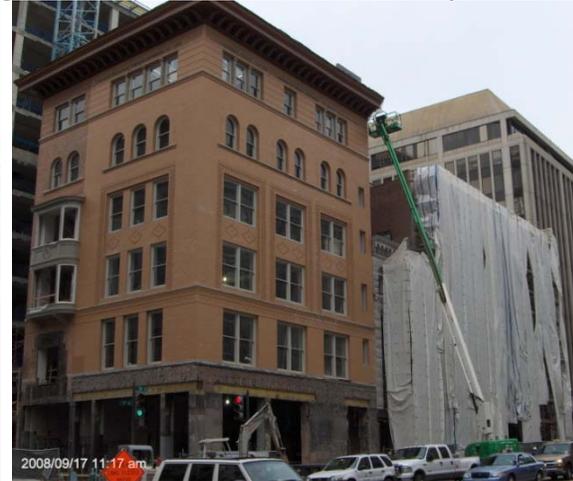
Fig. 3 – Corcoran Building Façade Restoration
