7700 ARLINGTON BLVD.
FALLS CHURCH, VA

TECHNICAL ASSIGNMENT I

CONSTRUCTION MANAGEMENT

2012 CAPSTONE PROJECT

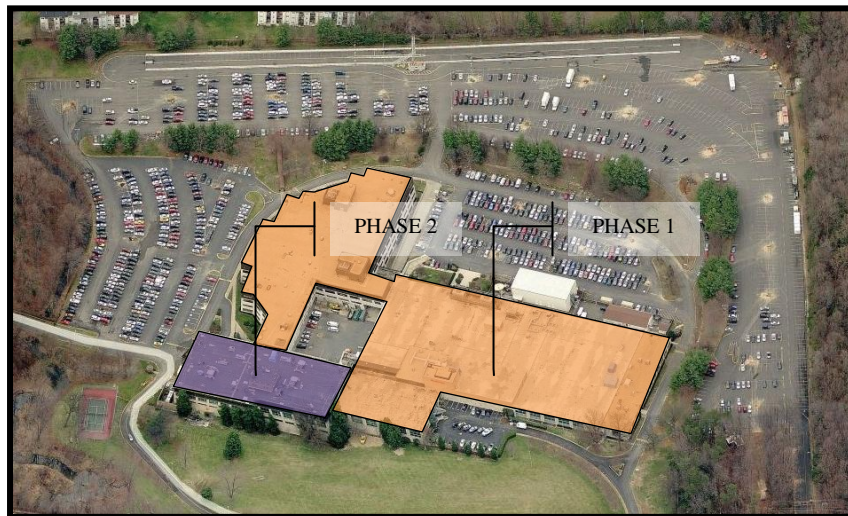
2-phase Construction Sequence

The first phase which is to include the Northwest building and Main building is to begin November 2010 and end July 2011. The second phase which is to include the Annex (or Southwest) building is to begin January 2011 and end May 2012. The sequence within each phase begins with Raytheon vacating the building, followed by the demolition, structure, façade/roof, building core/shell infrastructure, elevators, and tenant work. There will also be site improvements that will take about four months to complete.

Since there are three buildings on this jobsite a lot of coordination had to be done in order to figure out the correct sequence for the job. The 2-phase construction sequence, shown below, was developed due to the fact that Raytheon would still be occupying the space during construction and DHHQ would be moving into the space as construction is finishing up.

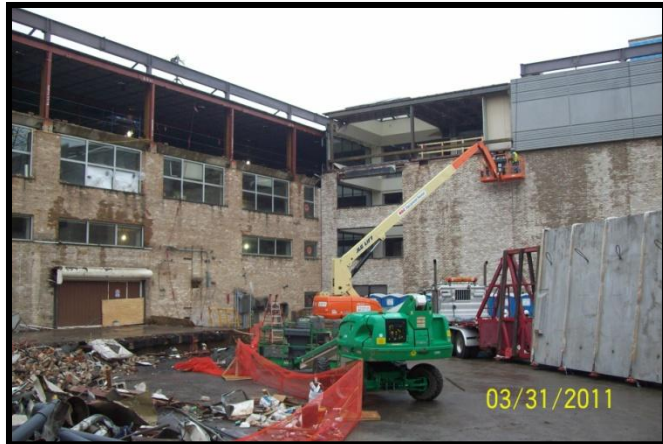
Demolition of Existing Parapet for Perimeter of Main Building

There are a few selective structural elements that need to be demolished. The existing fourth floor exterior wall assembly in the Northwest and Southwest buildings, along with the Northwest building roof assembly to the surface of the structural substrate will be removed. All interior partitions and associated doors and frames will need to be demolished unless otherwise noted on drawings. Other items that will be demolished include all existing ceilings and all floor finishes.

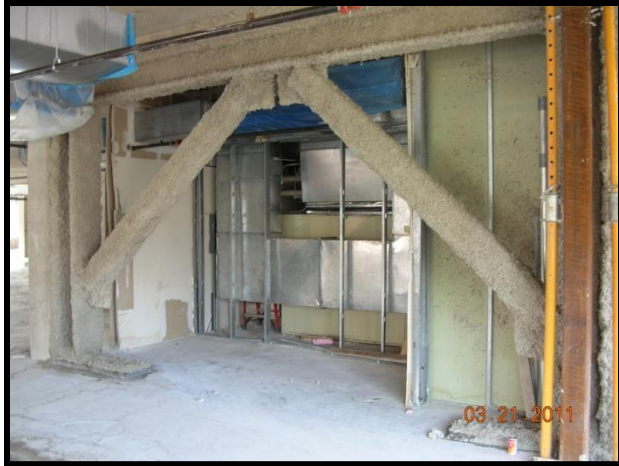
Installed Seismic Bracing

Seismic bracing enhancement is another part of the structural system that was renovated. In the Northwest building HSS 8x8x3/8 braced frames were used to support the structure while in the Southwest building HSS 6x6x61/4 and HSS 6x6x3/8 braced frames were used. HSS 6x6x3/8 and HSS7x7x3/8 were the primary seismic bracing for the Main building.

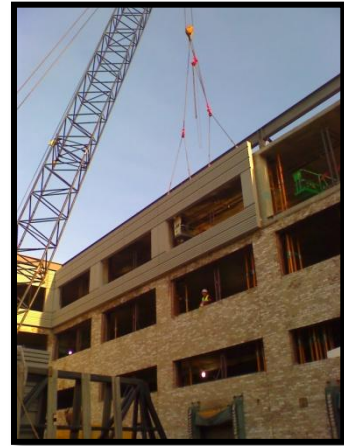
Precast Panel Installation

Precast panels will be installed on the entire façade of the building. The panels will be hoisted up using a movable crane and the precast panel connections will be installed by others not noted on drawings. The picture to the right shows a precast panel being hoisted into place.

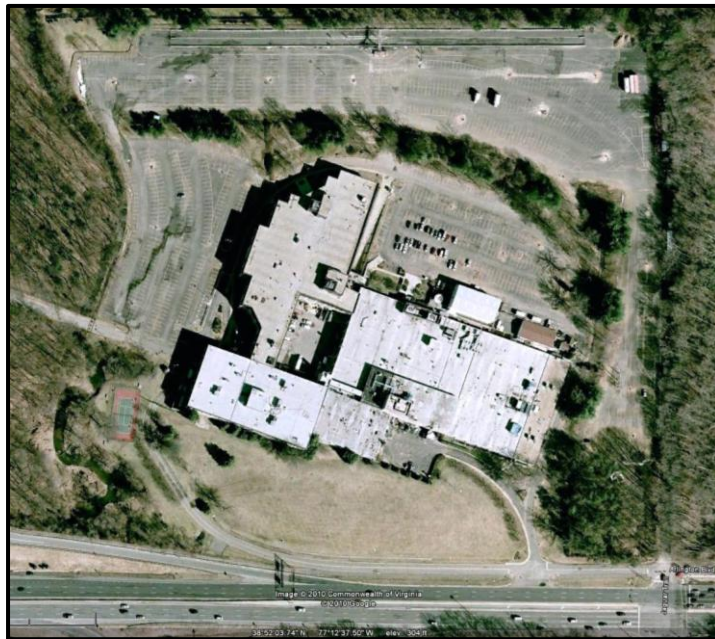
Existing 7700 Arlington Blvd. Site

7700 Arlington Blvd. was originally constructed between the 1950s and 1980s and is located in Falls Church, Virginia. The two major roads that surround the building are Route 495 (The Capital Beltway) and Route 50 (Arlington Blvd.). The main entrance into the site is off of Route 50 and since this is an already existing structure there is plenty of space to store equipment, trailers, and other construction items for the duration of construction. This site was originally home to Raytheon, a company that specializes in defense, homeland security and other government markets. [1] Demolition and construction will be going on prior to Raytheon vacating the building. The picture below shows the existing three buildings and the entire site.

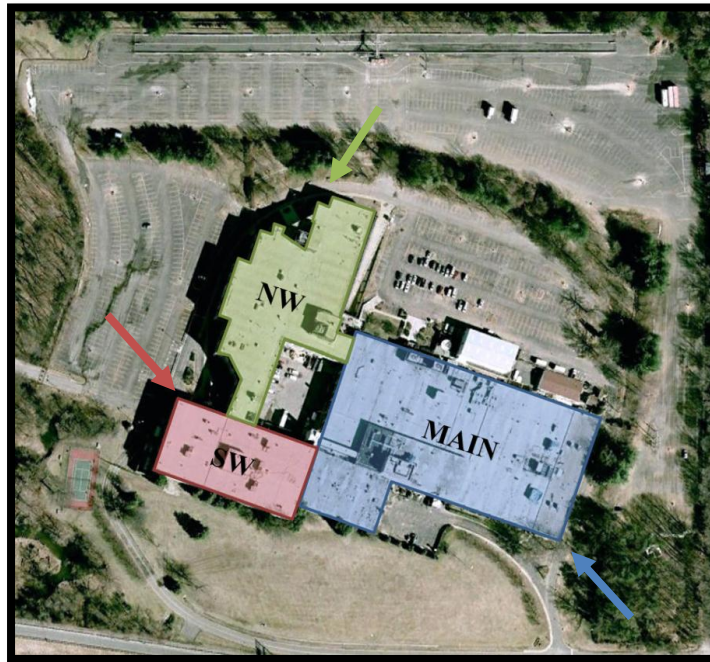
Existing 7700 Arlington Blvd. Site

7700 Arlington Blvd. sits on approximately 43.63 acres with an existing gross floor area of 684,651 square feet. The Northwest Building is four stories tall with a height of 47 feet and a gross square footage of 267,436 SF. The Southwest Building is four stories tall with a height of 43 feet 10 inches and a gross square footage of 159,005 SF. The Main Building is two stories tall with a height of 31 feet 10 inches and a gross square footage of 258,209 SF. Parking outside the building include 29 handicapped spots, 4 van handicapped spots, and 1811 regular parking spots. There are plenty of parking spots for construction employees during the project as well as lay down areas for material. Below are a few pictures that show the existing building and site conditions, including parking.
